Firefighter Fatality Investigation

Investigation FFF FY 13-06

West, Texas April 17, 2013

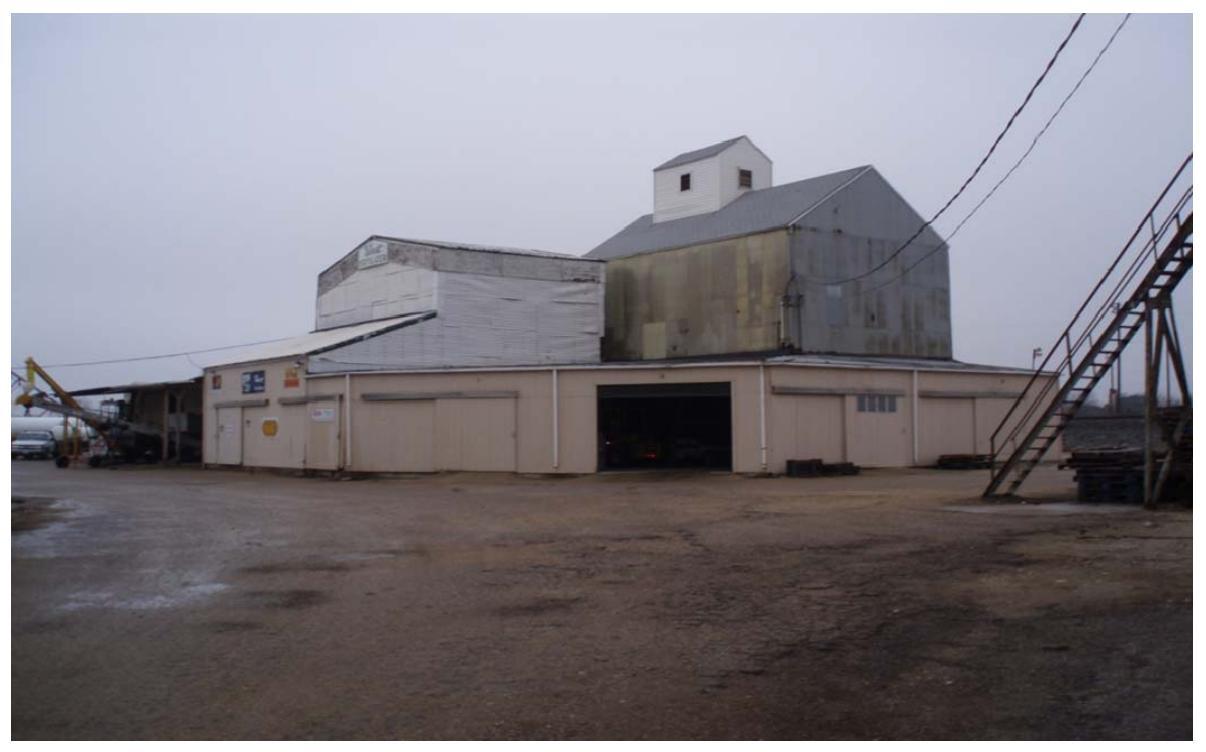
Ammonium nitrate with 34 percent total nitrogen content, also referred to as 34-0-0 (with 97 percent pure ammonium nitrate), was stored in bulk granular form in an open system consisting of a vertical bin constructed of wood walls approximately 24 feet high.

The bin contained an estimated 20-30 tons of ammonium nitrate. An air conditioner was installed to maintain low humidity levels and reduce "shrinkage loss" and caking of the ammonium nitrate product in the vertical bin. Investigators determined through interviews of the employees that the air conditioner was not in use the day of the incident.

View of the building from the northeast

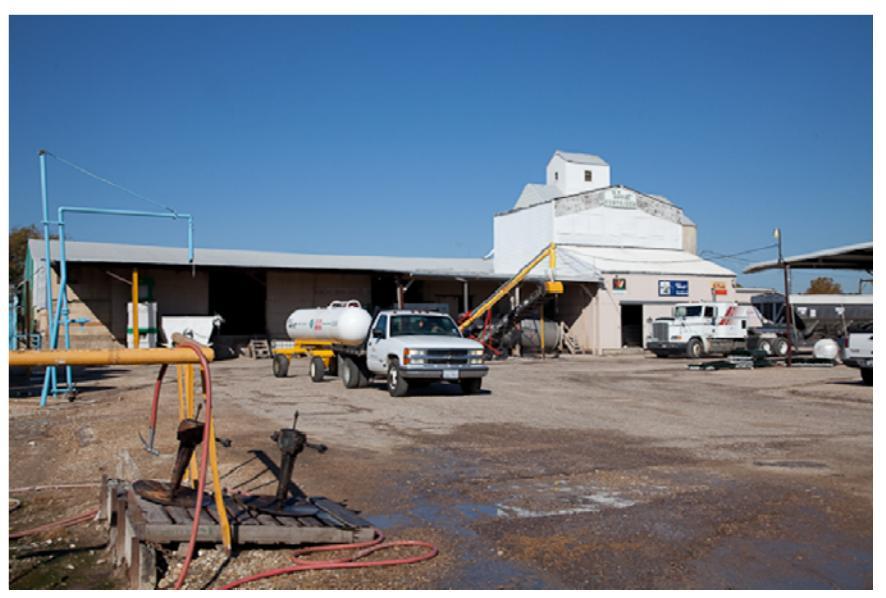
East side of the processing building where the mixing and delivery of chemicals occurred

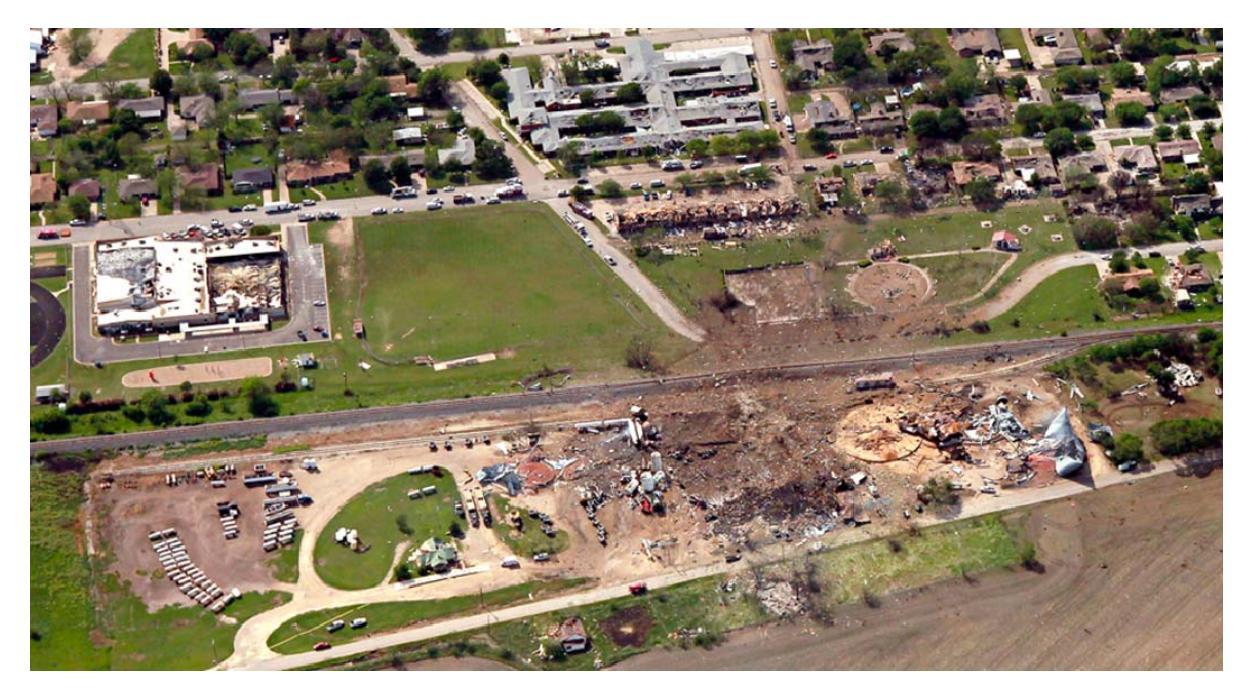
View of the site prior to scene excavation and examination

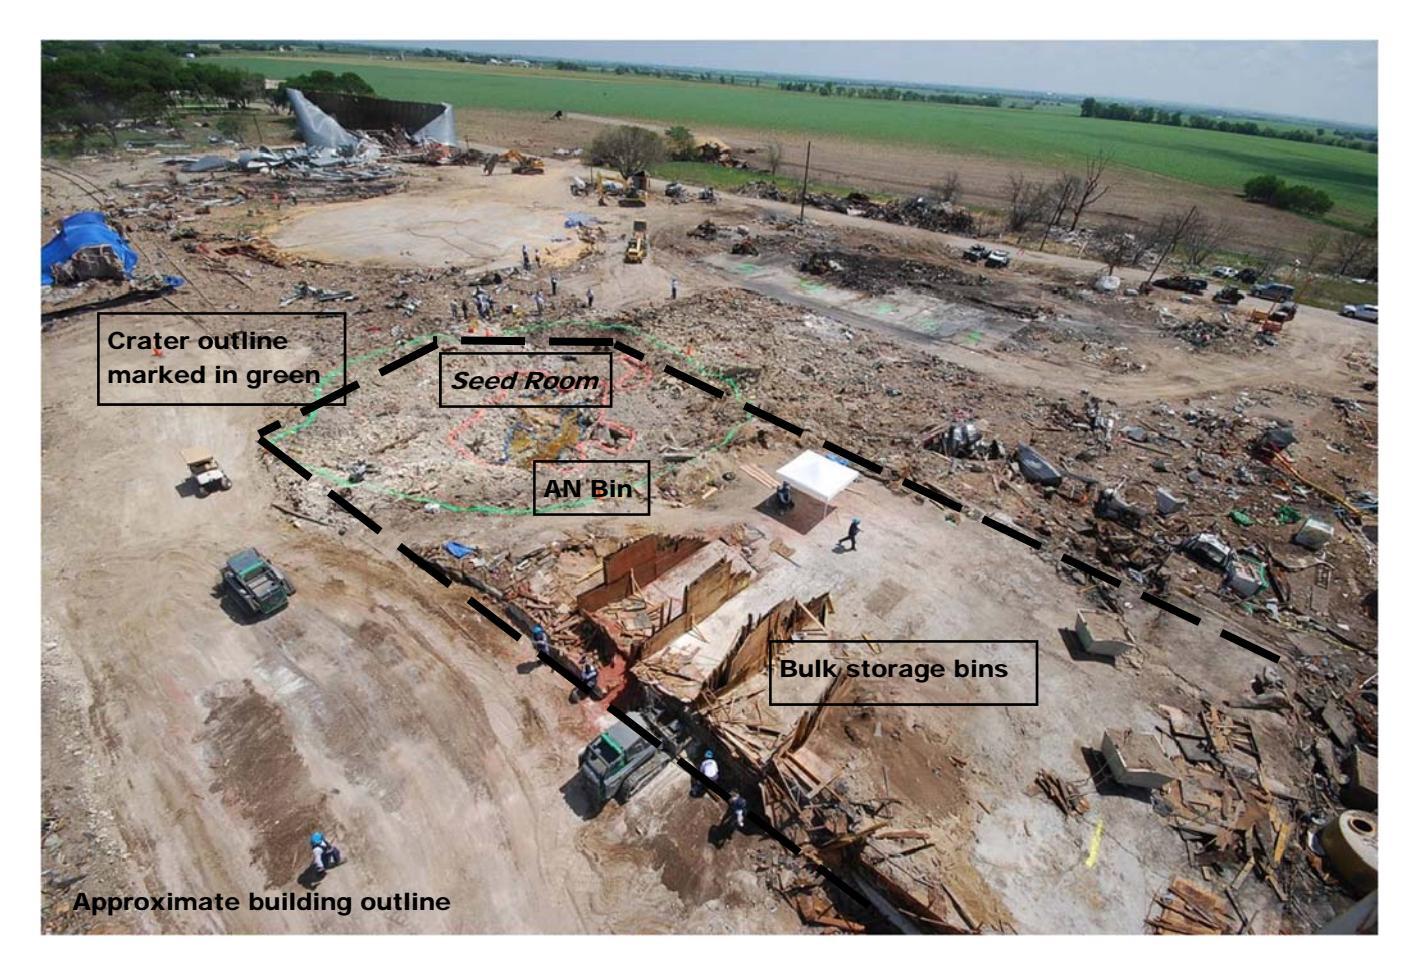
View of the scene during the examination and reconstruction

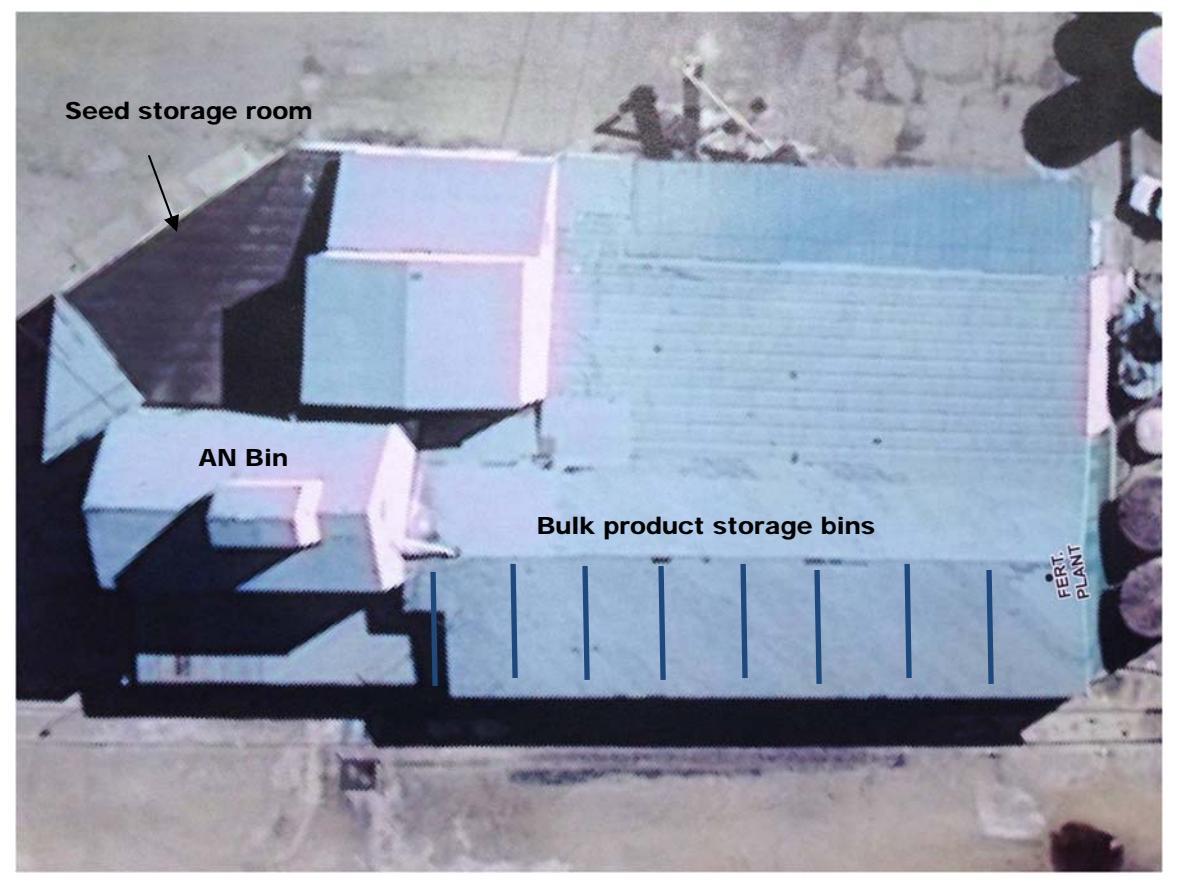
Comparison photos of the reconstruction and pre-blast photos of the processing building

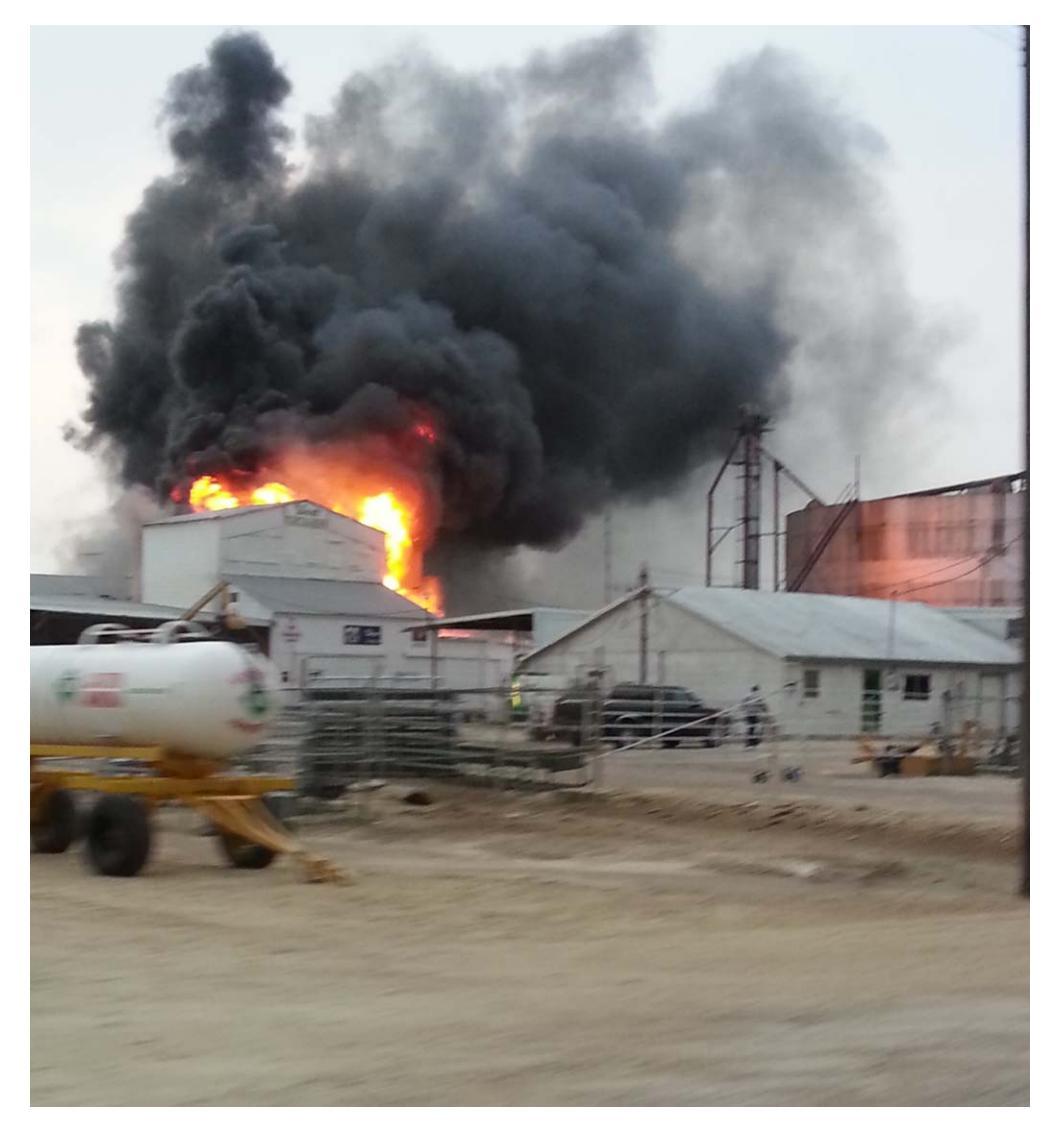
Passerby view of the east side of the building, approximate time 7:38 p.m. (Photo by Macik)

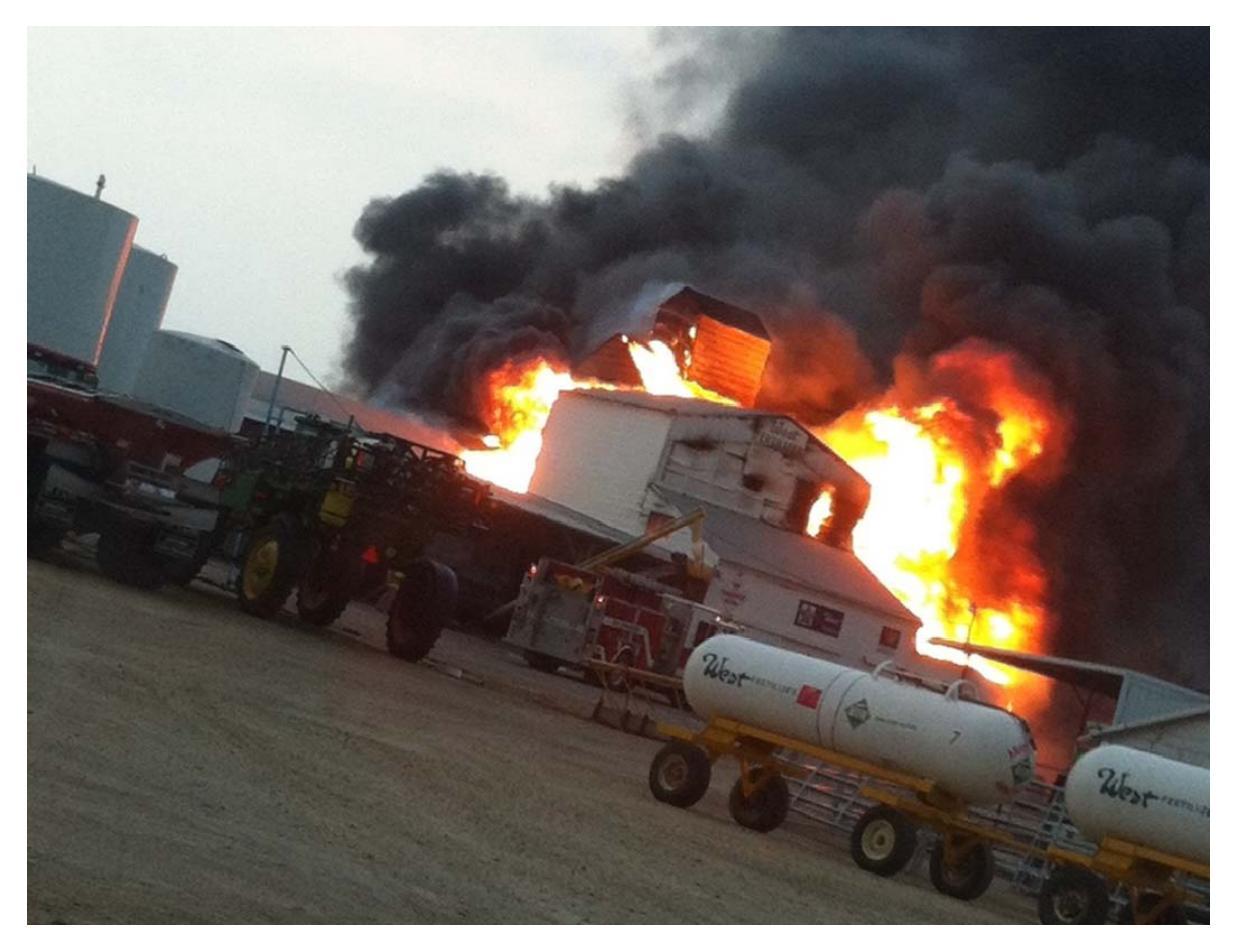
Passerby view of Engine 1 position at east side of building, approximate time 7:40 p.m. (Photo by Campbell)

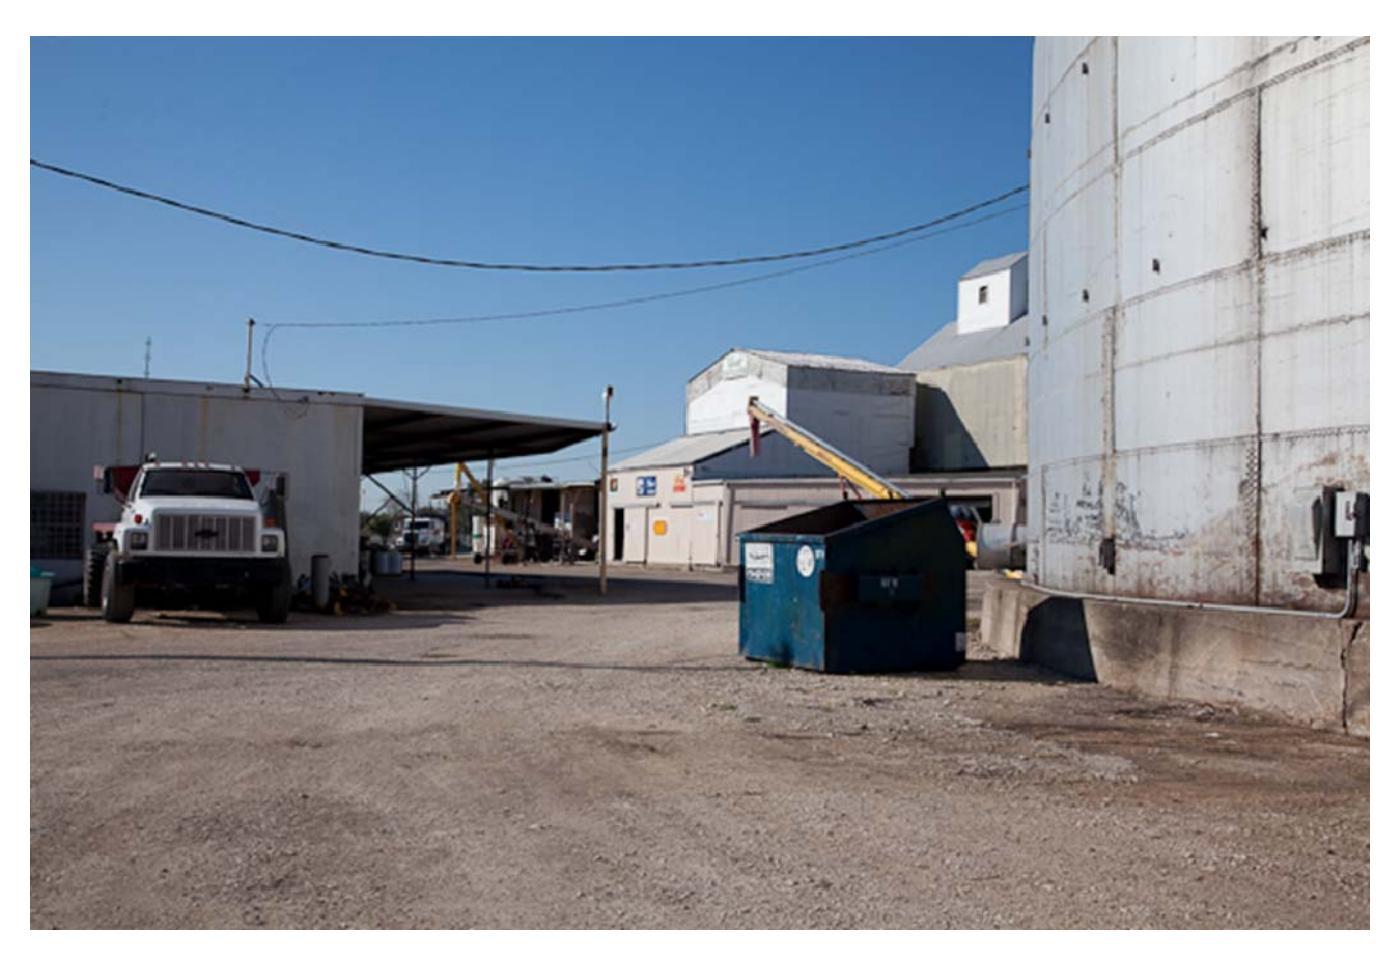
The white brush truck was positioned under the electric service lines in this area before moving back (Insurer photo)

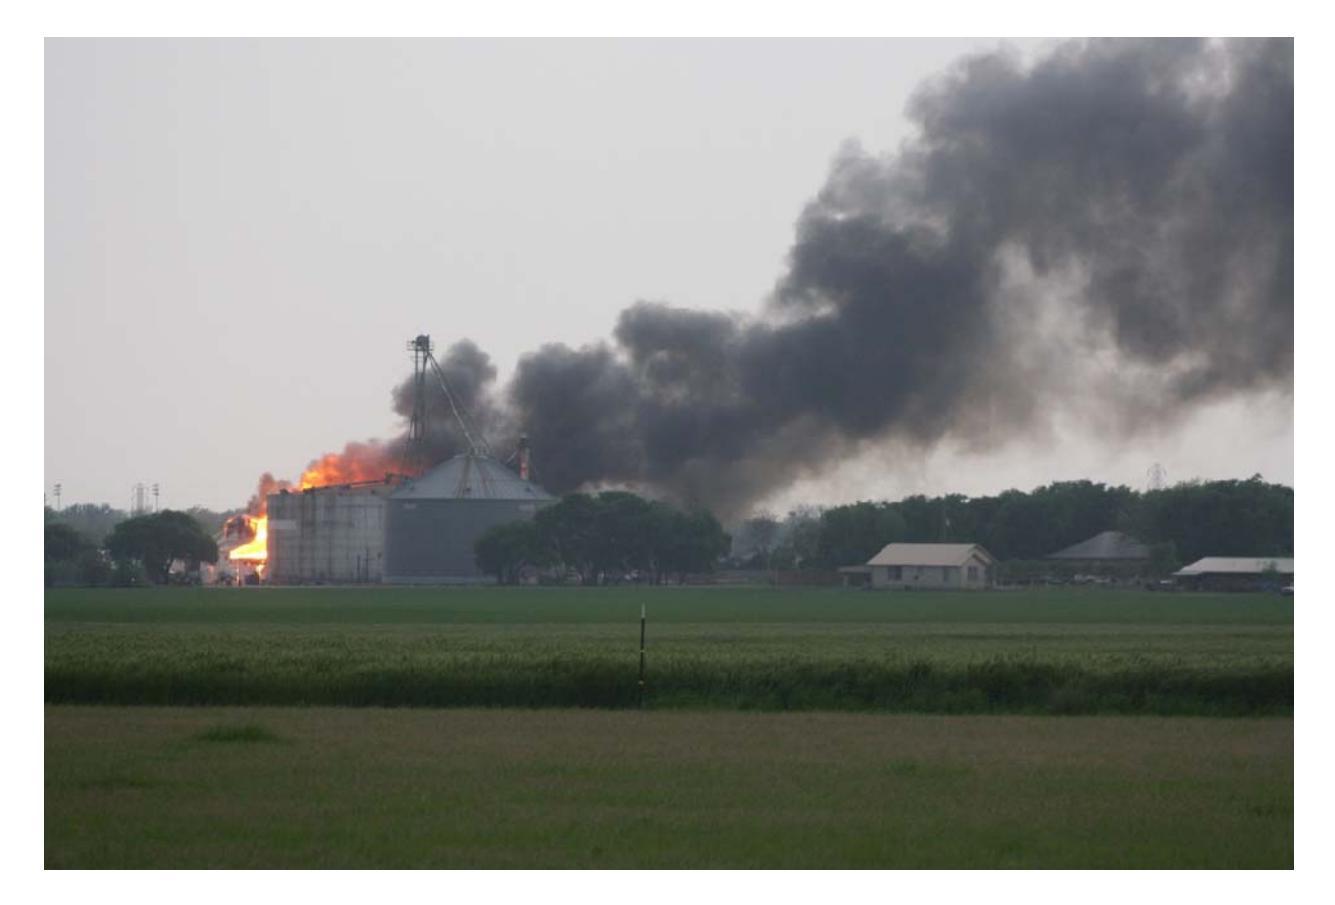
View of the site from the northeast (Photo by Wright)

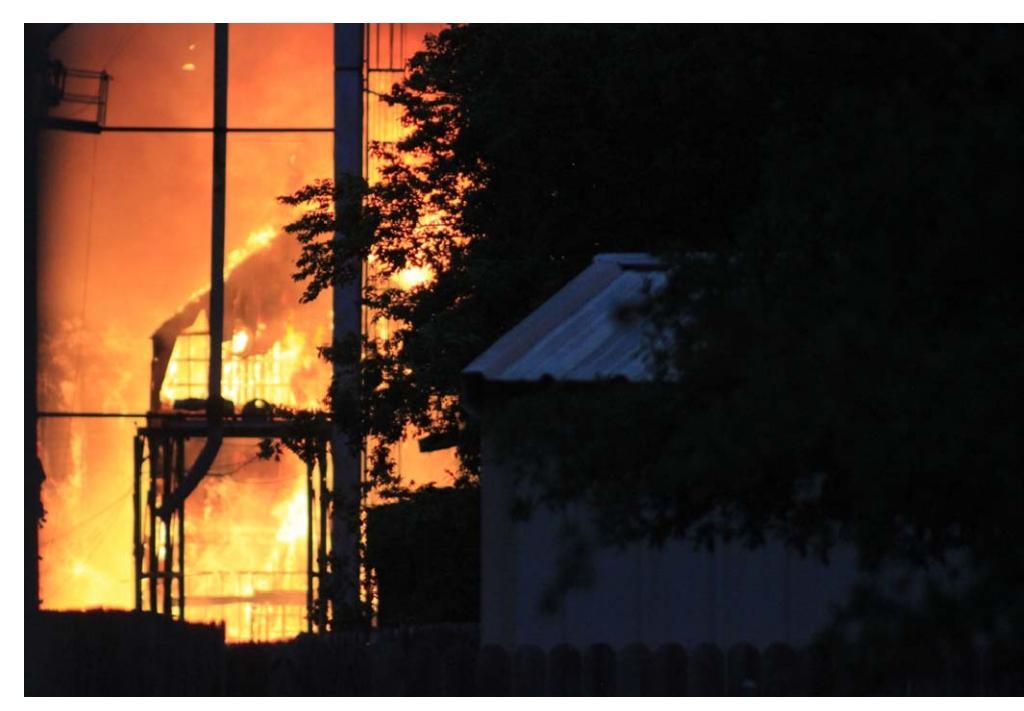
View from the north at approximate time 7:48 p.m. (Photo by Bajer)

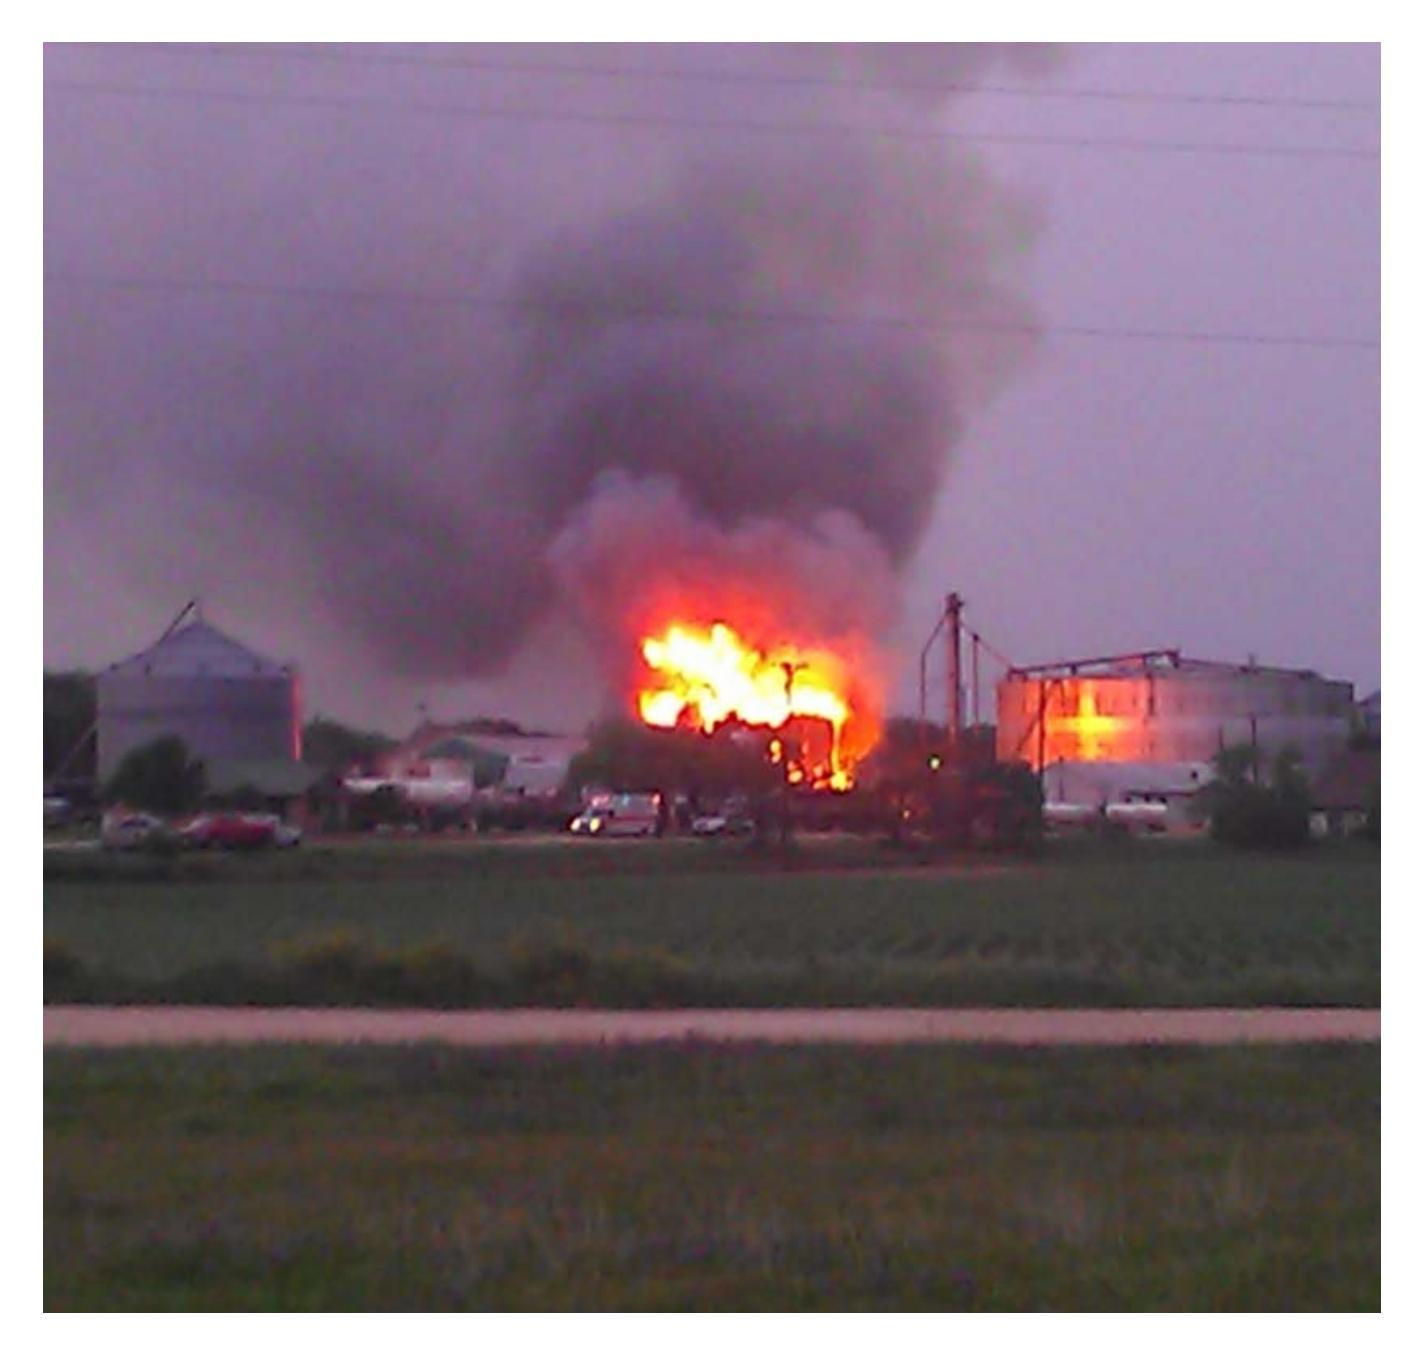
View from the southeast at approximate time 7:50 p.m. (Photo by Nathan Nors)

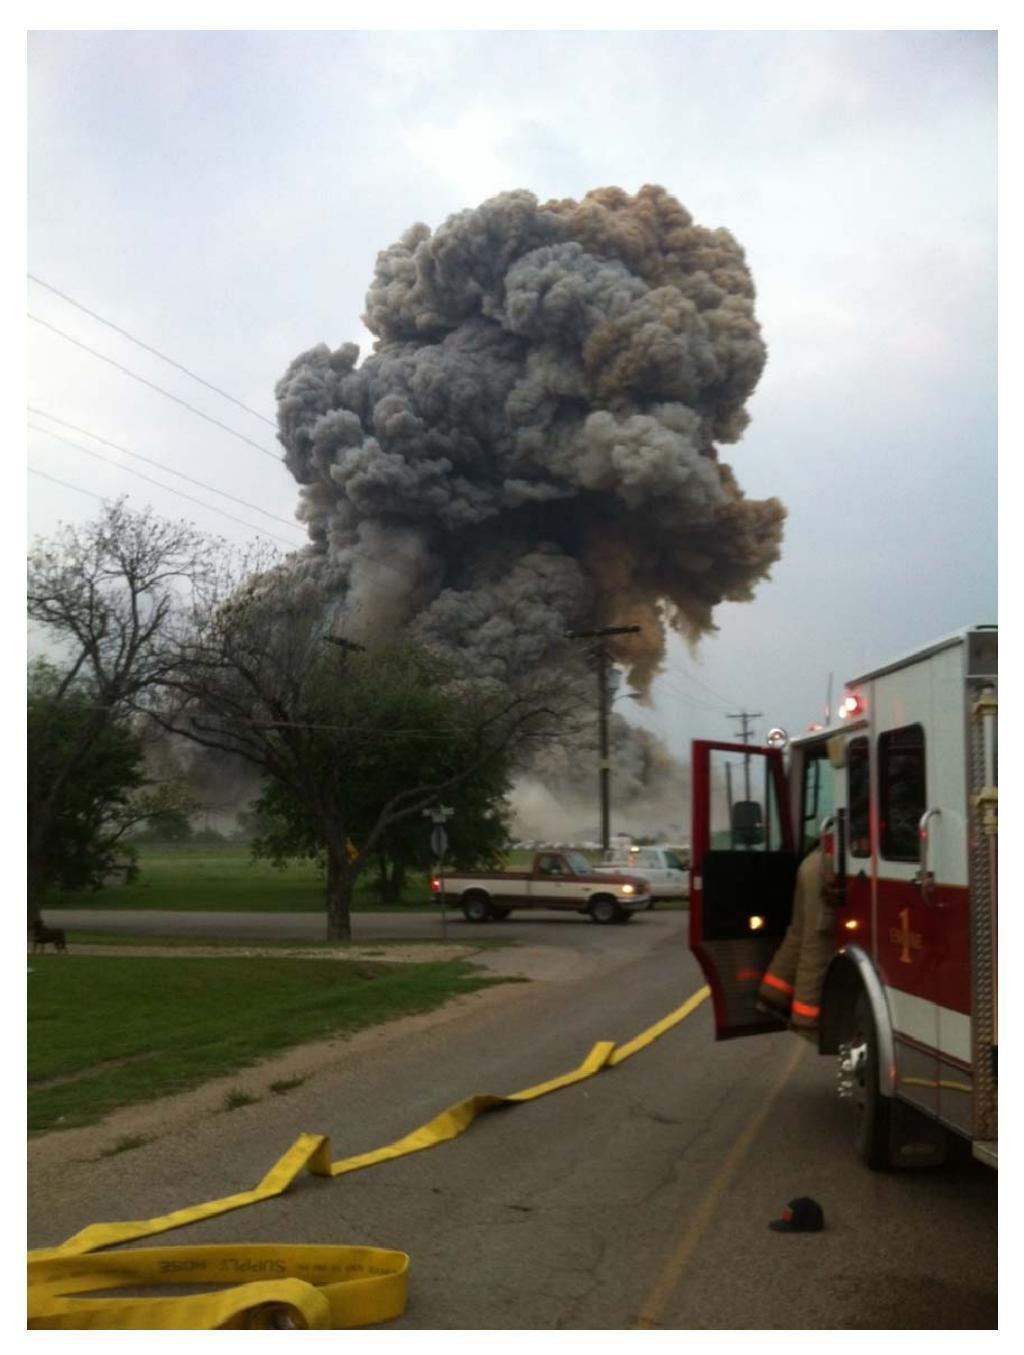
View of the plume of smoke after the explosion (Photo by Kapavik)

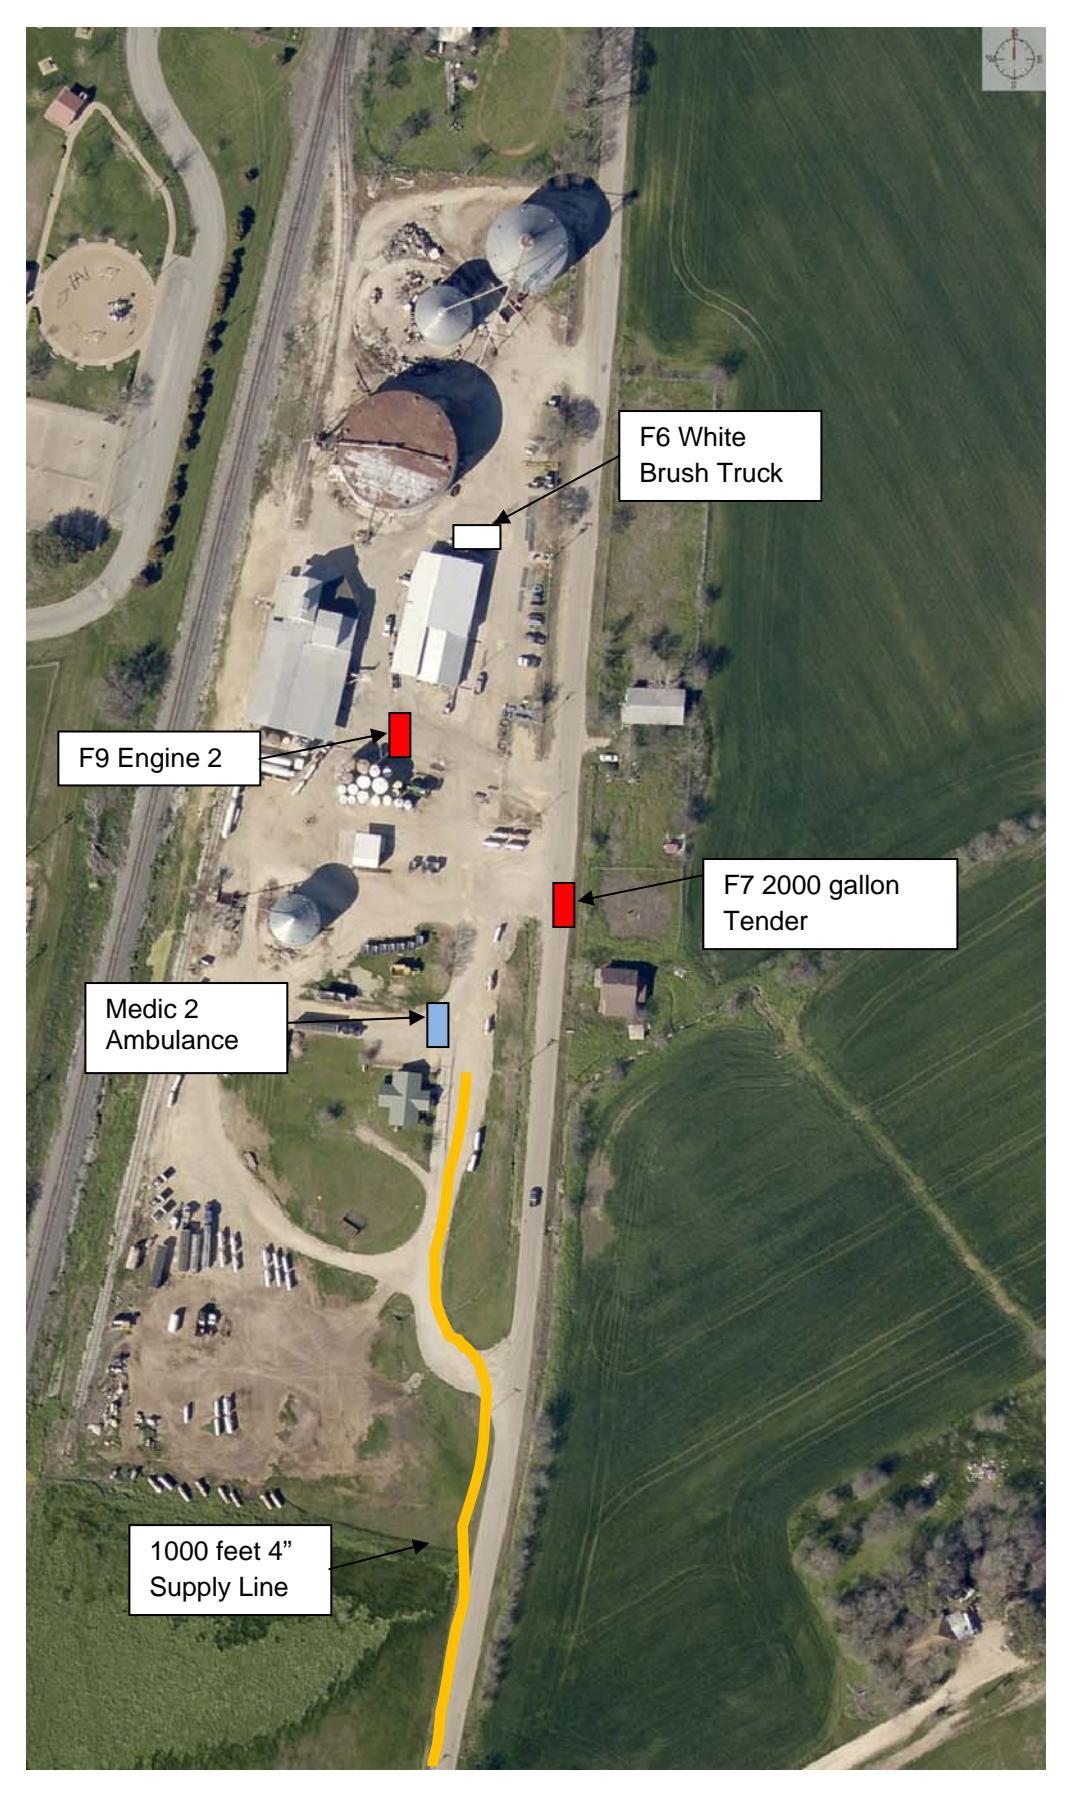
Approximate positions of apparatus at time of explosion
